Successes and Failures of Renovating Two Ponds at Imperial National Wildlife Refuge

Tammy Knecht

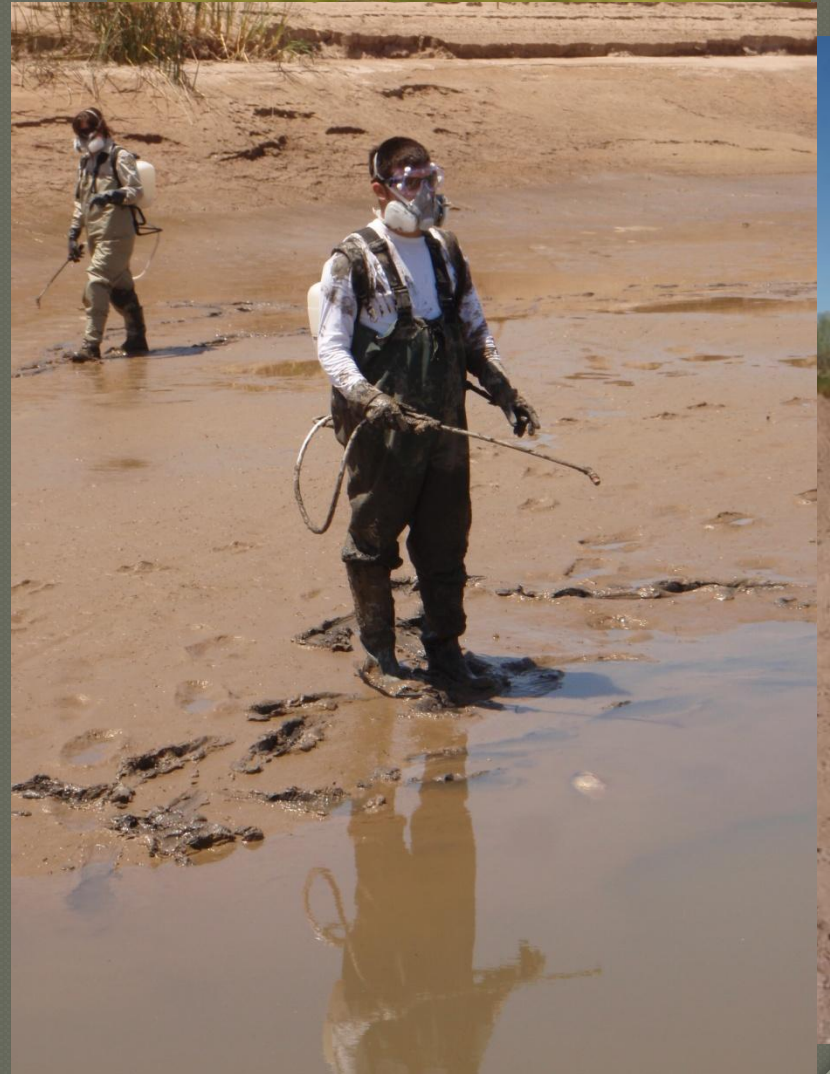
Application Method of 1st Treatment, Pond 1

- Pond was dewatered
 - Can it be done?
- Backpack Sprayers used
- Slow drip bottles system for upwellings

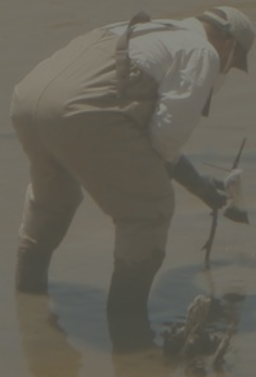
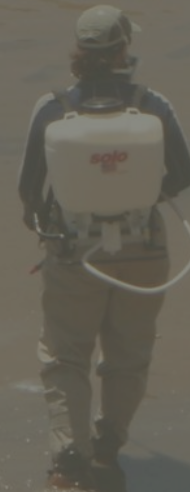
1st Treatment Pond 1

- 1st Application April 29, 2009
- 2nd Application July 9, 2009

- 4.0ppm of rotenone used for both applications

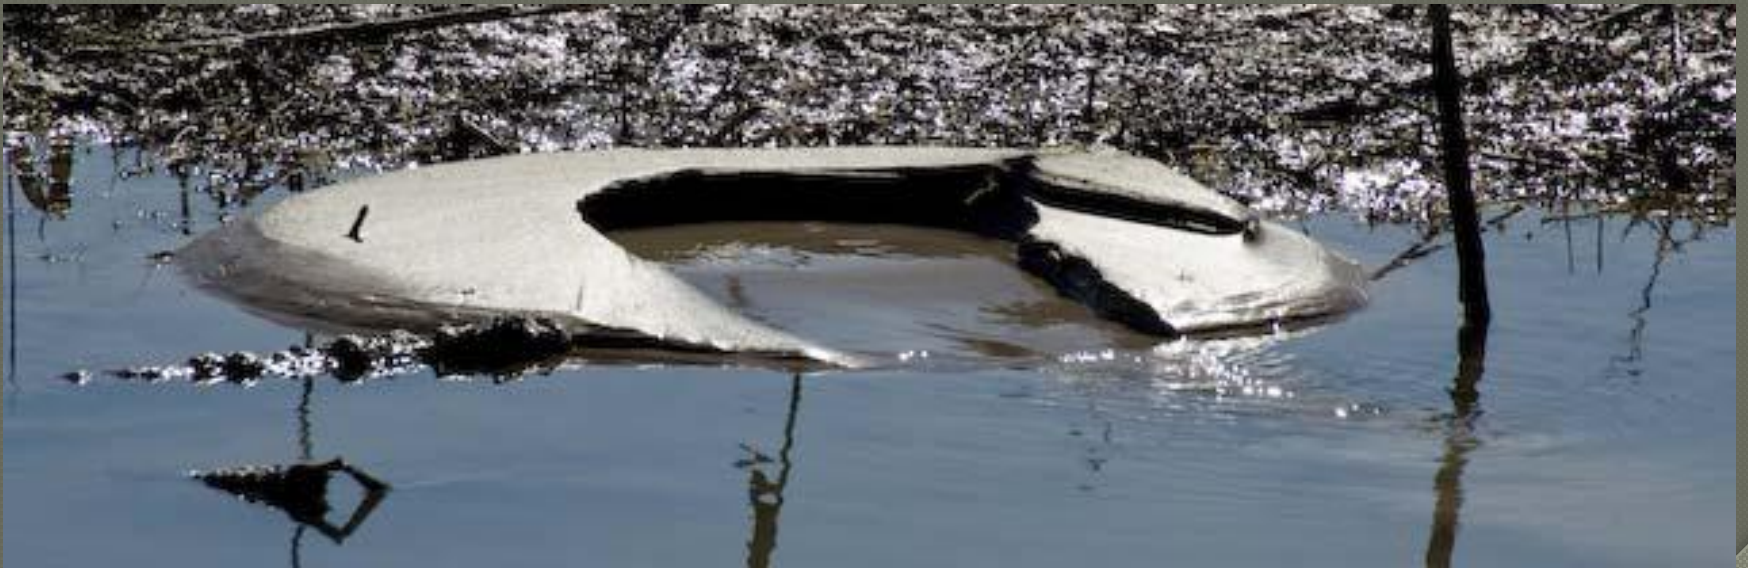
1st Treatment Pond 1 Problems

- Upwellings decreased effectiveness of Rotenone
 - Gave fish areas to escape from Rotenone
 - Constant water supply

- Unsuccessful kill
- Pond was not able to be completely dewatered
- Numerous upwellings to deal with
- 2nd Treatment necessary

- Cut weeds back
- Use a higher concentration for mosquitofish
- Treat pond at full pool
 - Dewatering a pond is expensive and ineffective

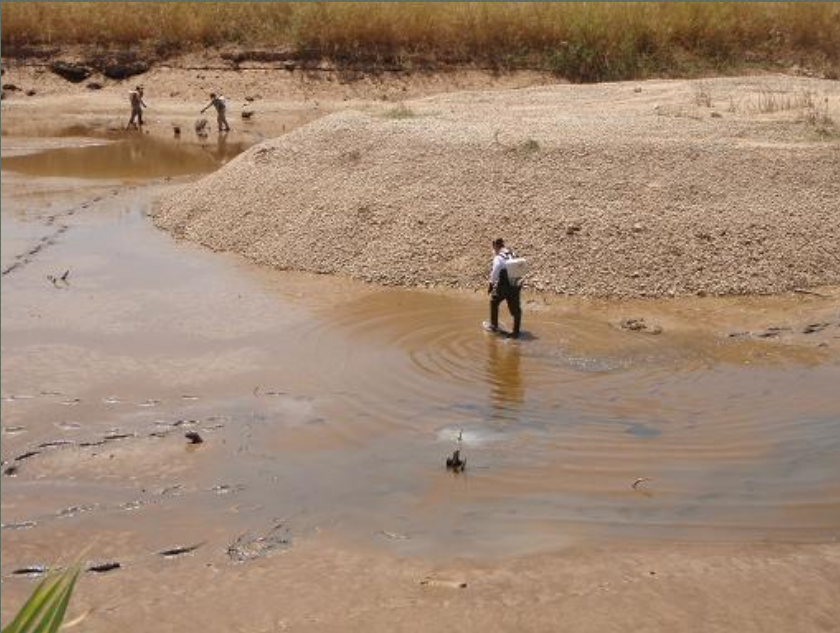
1st Treatment Pond 1 Problems

- Large amount of vegetation on 2nd application

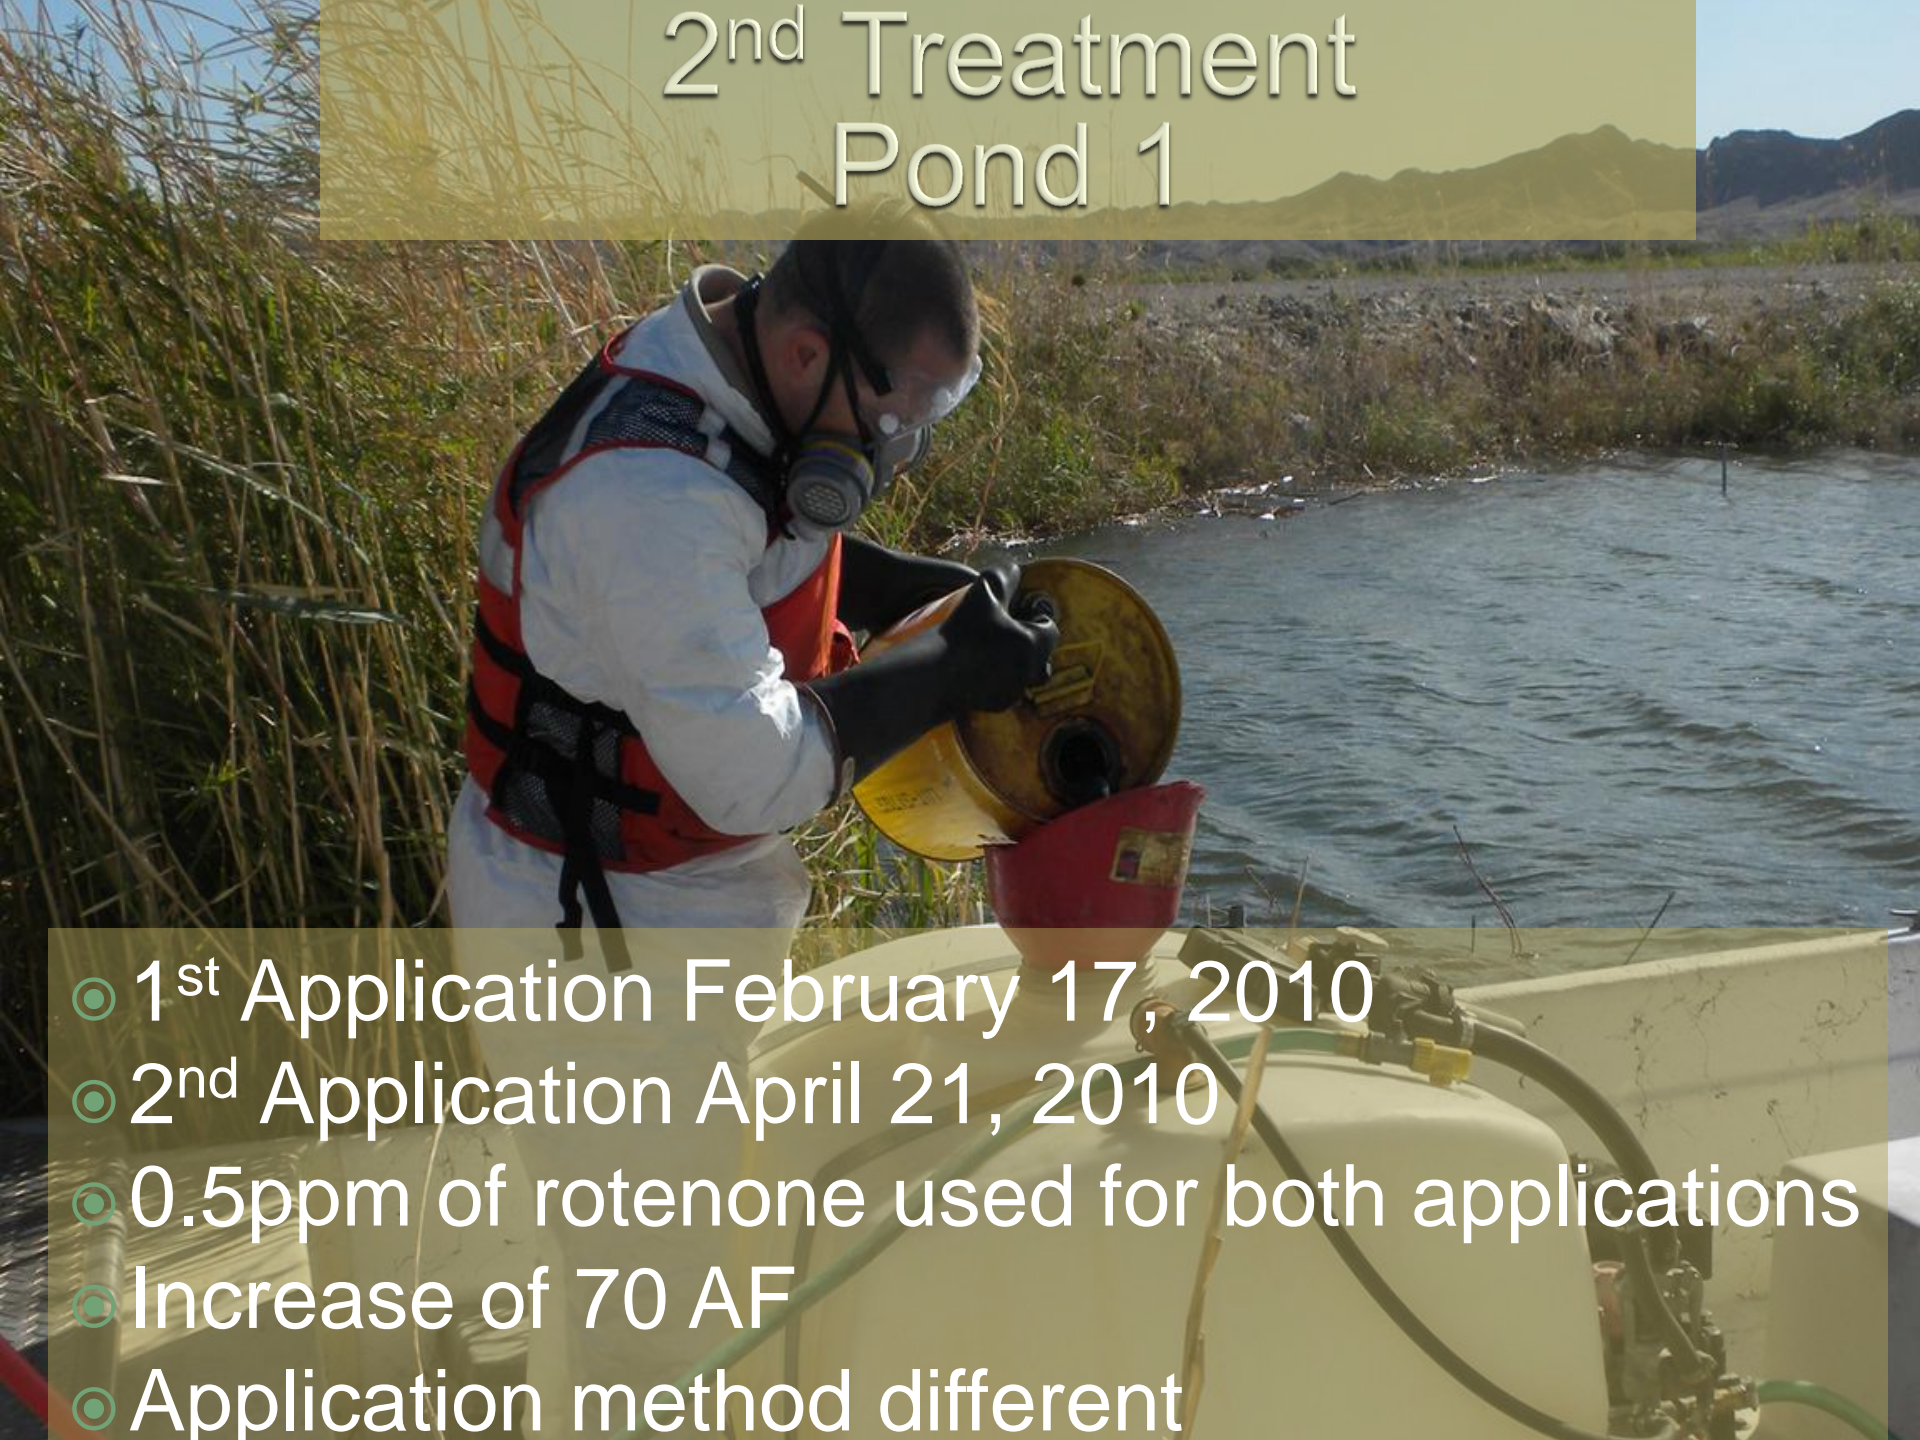
2nd Treatment Pond 1

- 1st Application February 17, 2010
 - 2nd Application April 21, 2010
 - 0.5ppm of rotenone used for both applications
 - Increase of 70 AF
 - Application method different

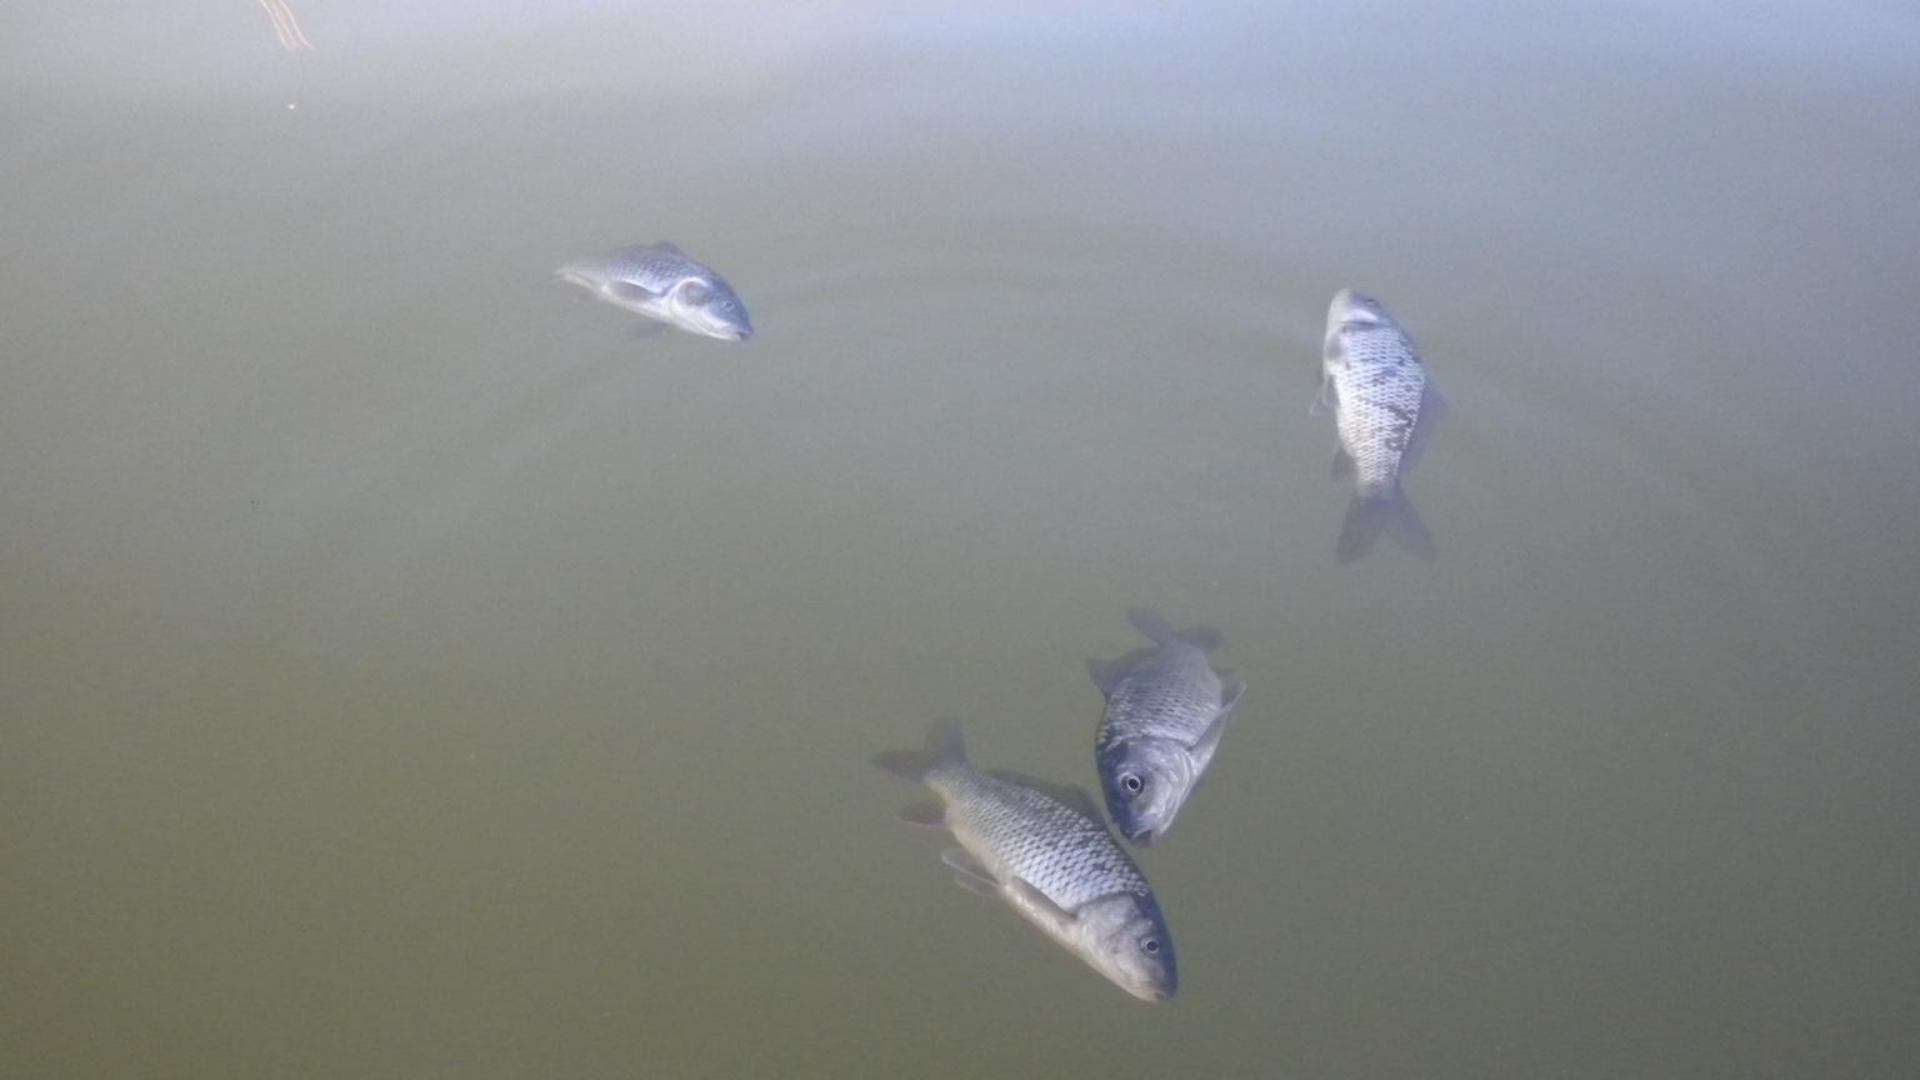
Pond 3

- 1st Application February 17, 2010 4.0ppm
- 2nd Application April 21, 2010 0.5ppm
- Application method same as pond 1, 2nd treatment.

An underwater photograph showing five fish swimming in a pond. The water is a murky, brownish-green color. The fish are of various sizes and are scattered across the frame. One fish is in the upper left, another in the upper right, and a group of three is in the lower center. The lighting is somewhat dim, typical of an underwater environment.
